# Big Tujunga Dam Seismic Rehabilitation and Spillway Modification Project

# Design

- Thickened Arch to resist seismic loads
- Central overtopping spillway and parapet walls to safely pass PMP
- Erosion protection measures
- New discharge valves
- New electrical / new generator
- New control house with seismic imp factor 1.25

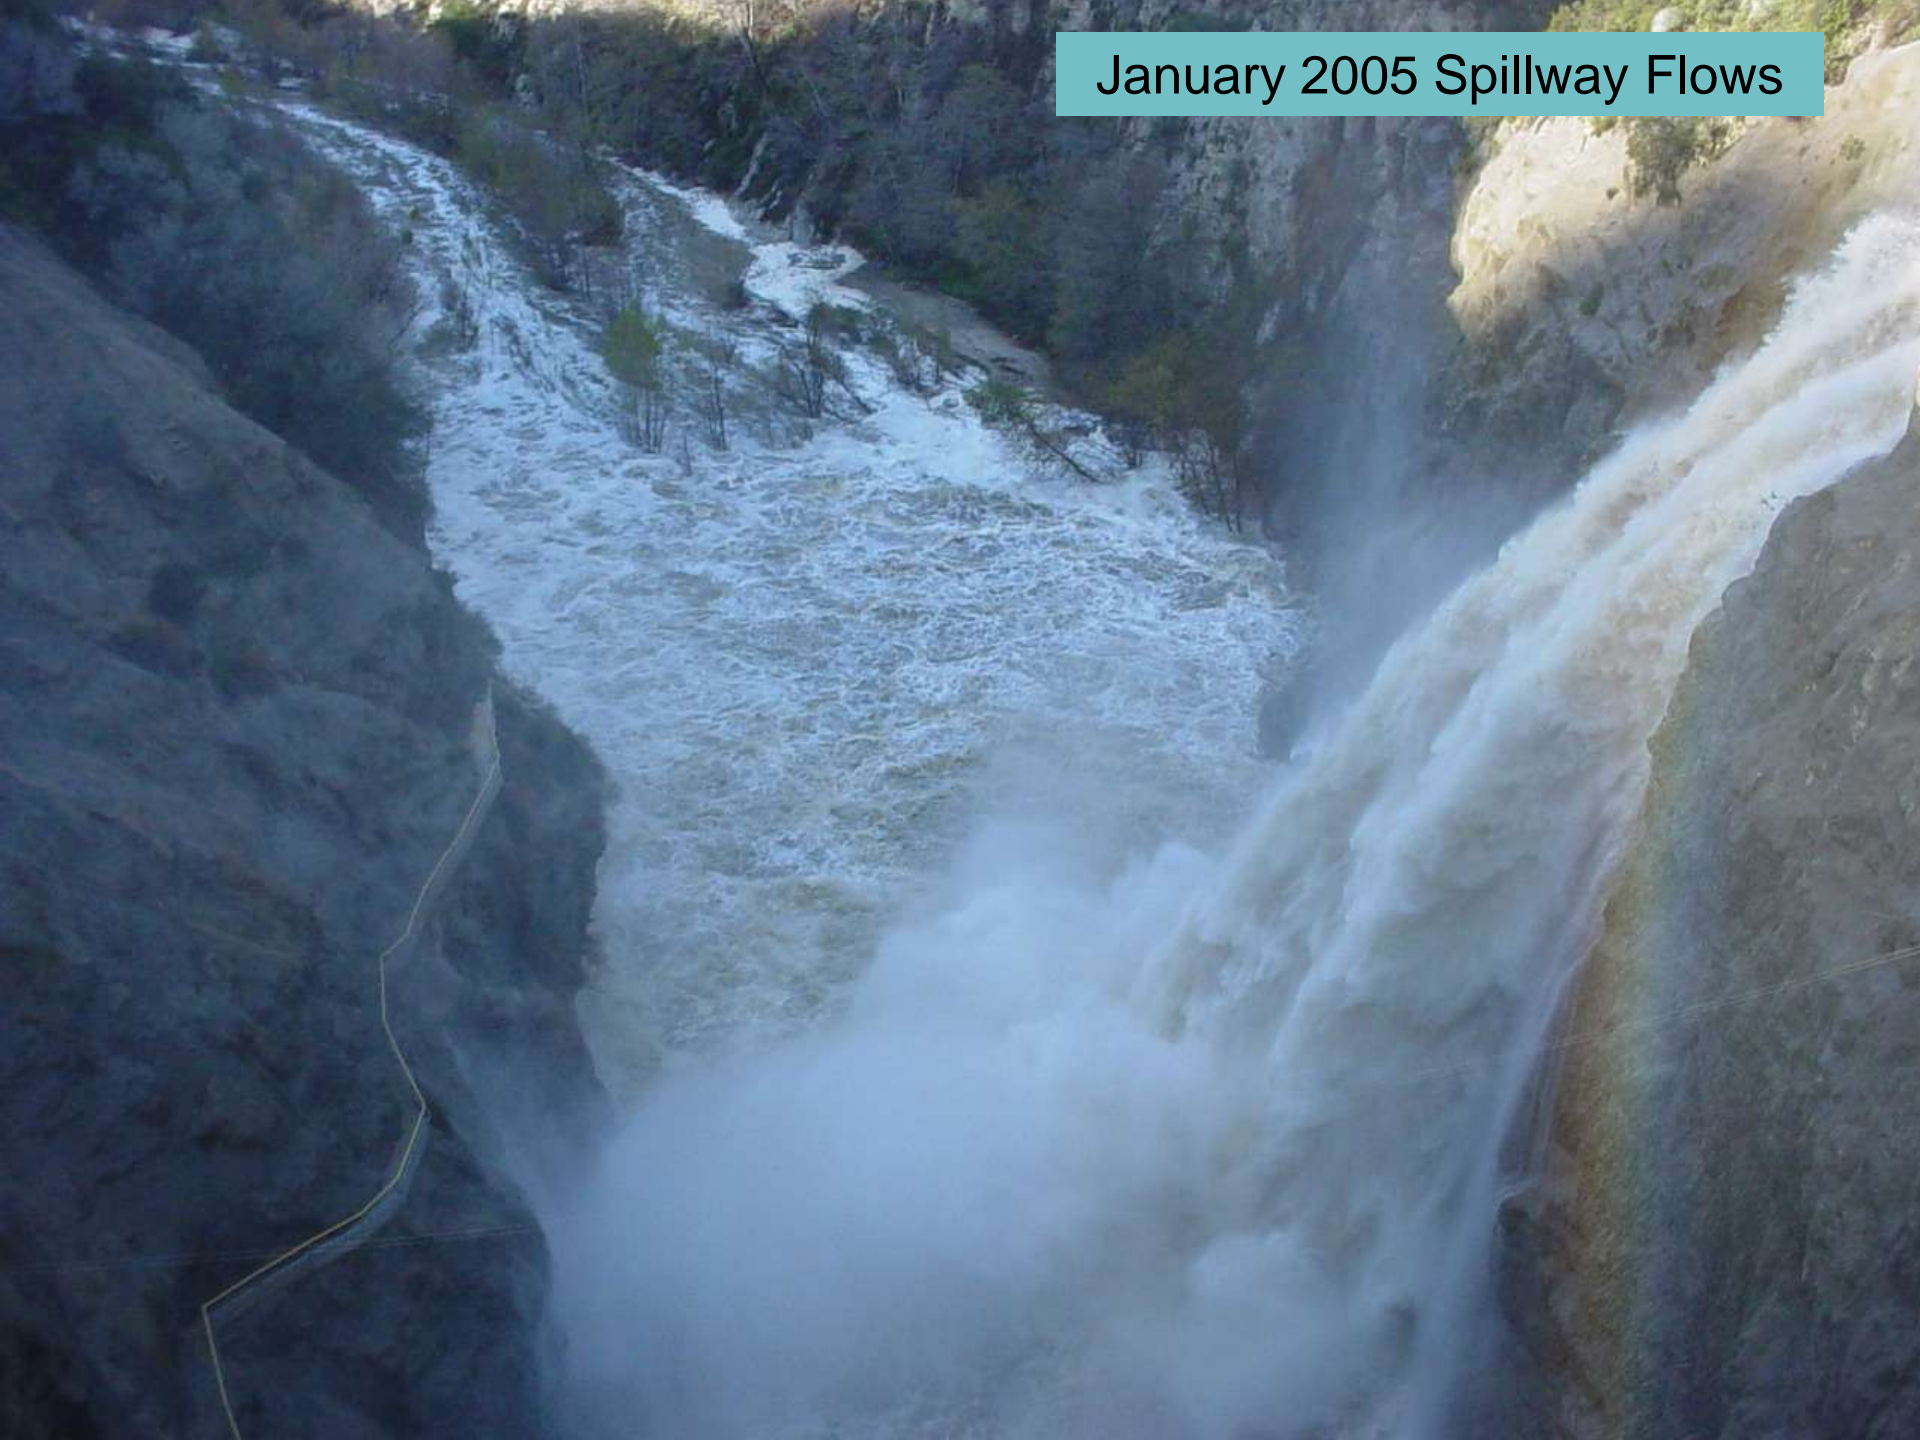
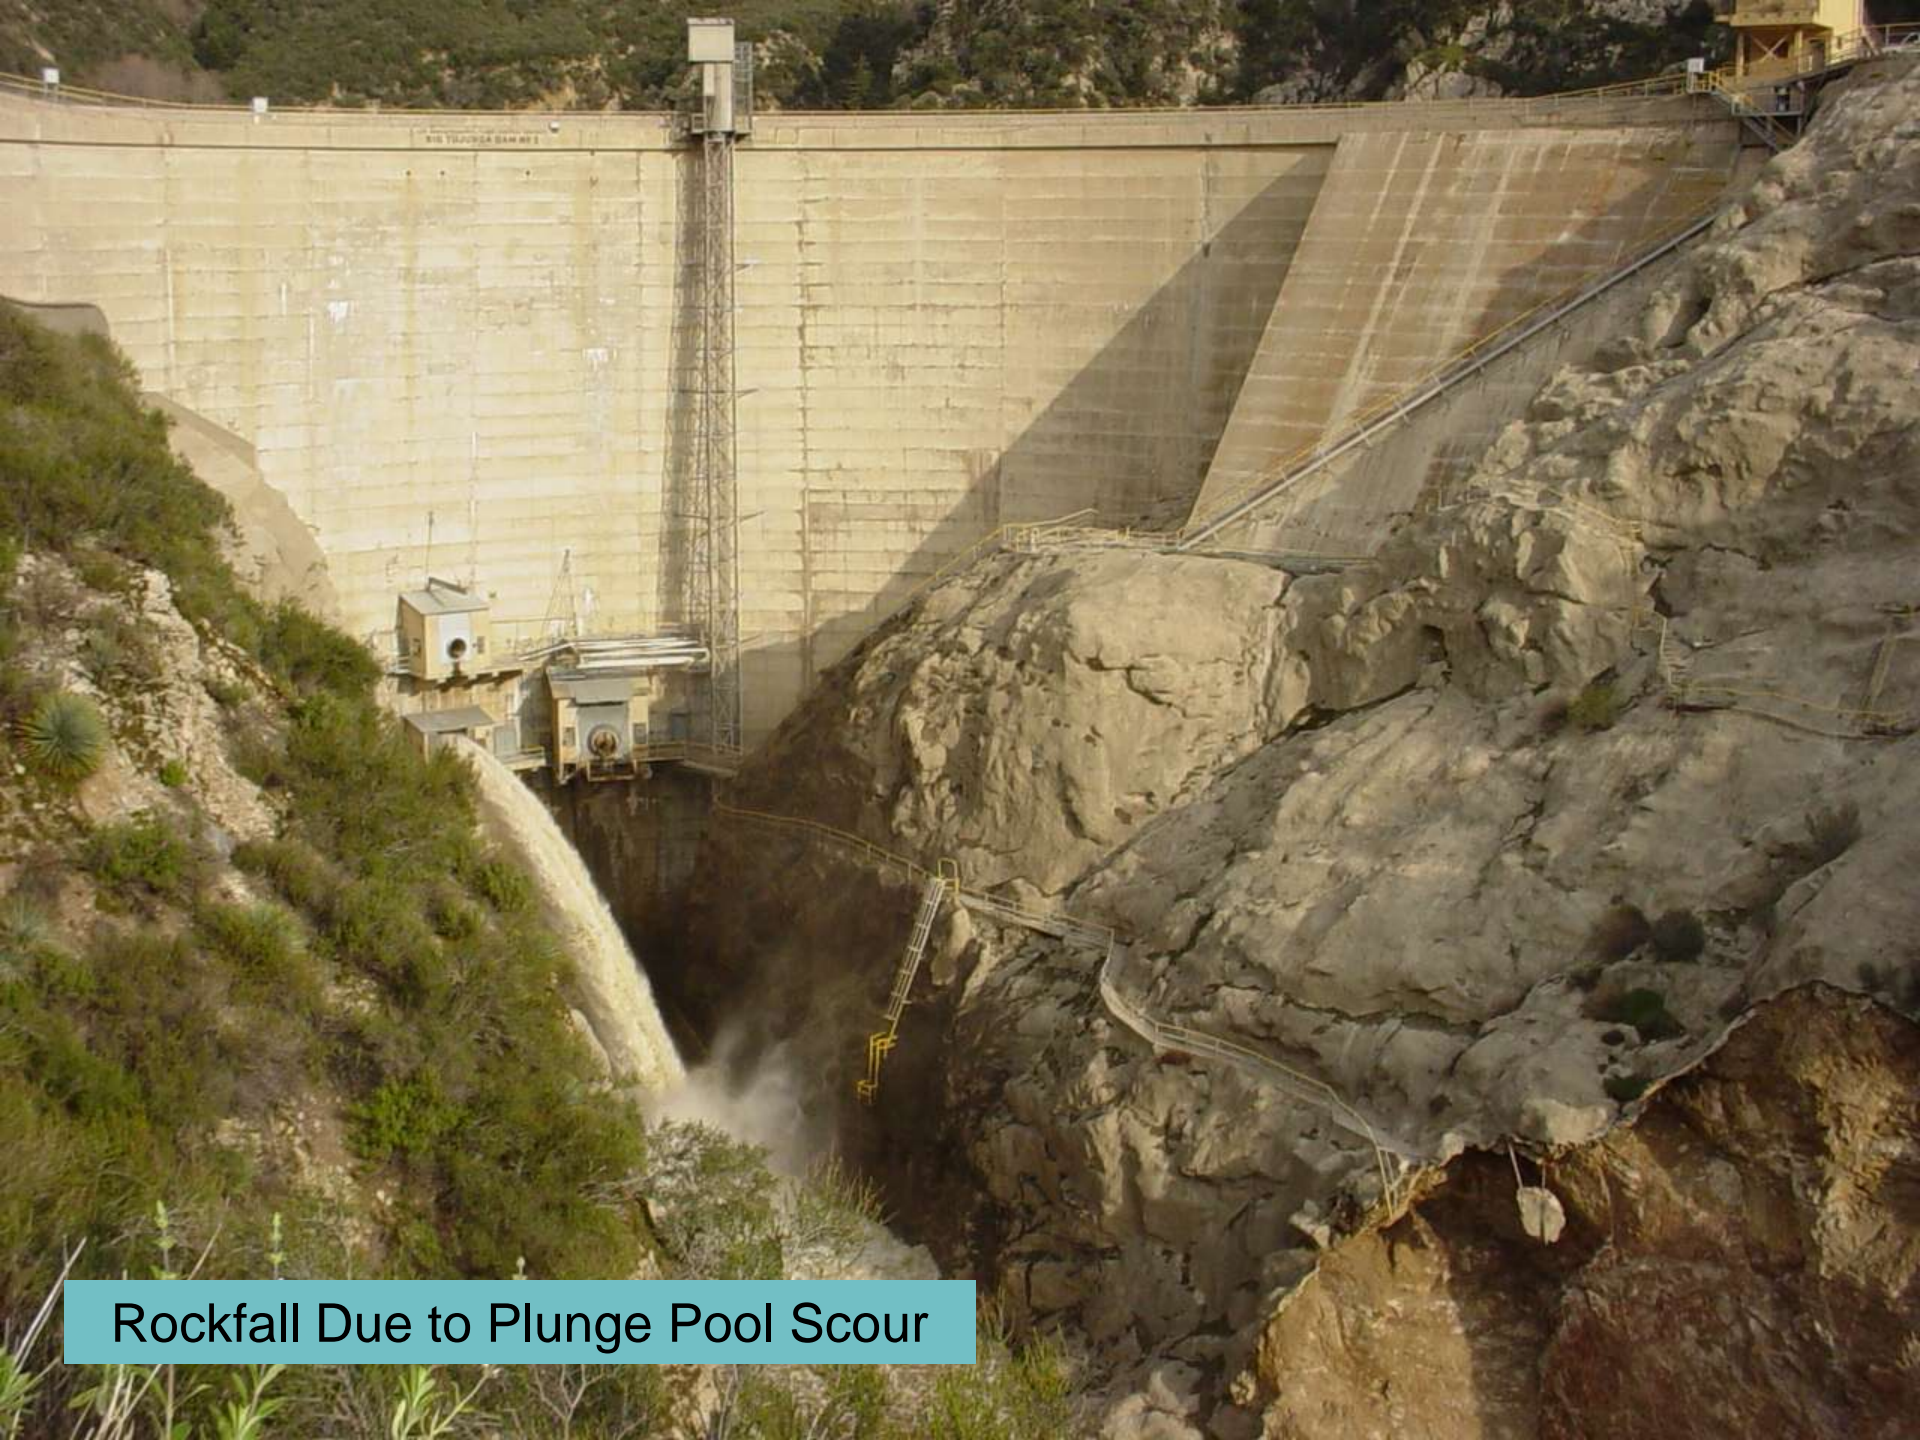
## January 2005 Spillway Flows

Rockfall Due to Plunge Pool Scour

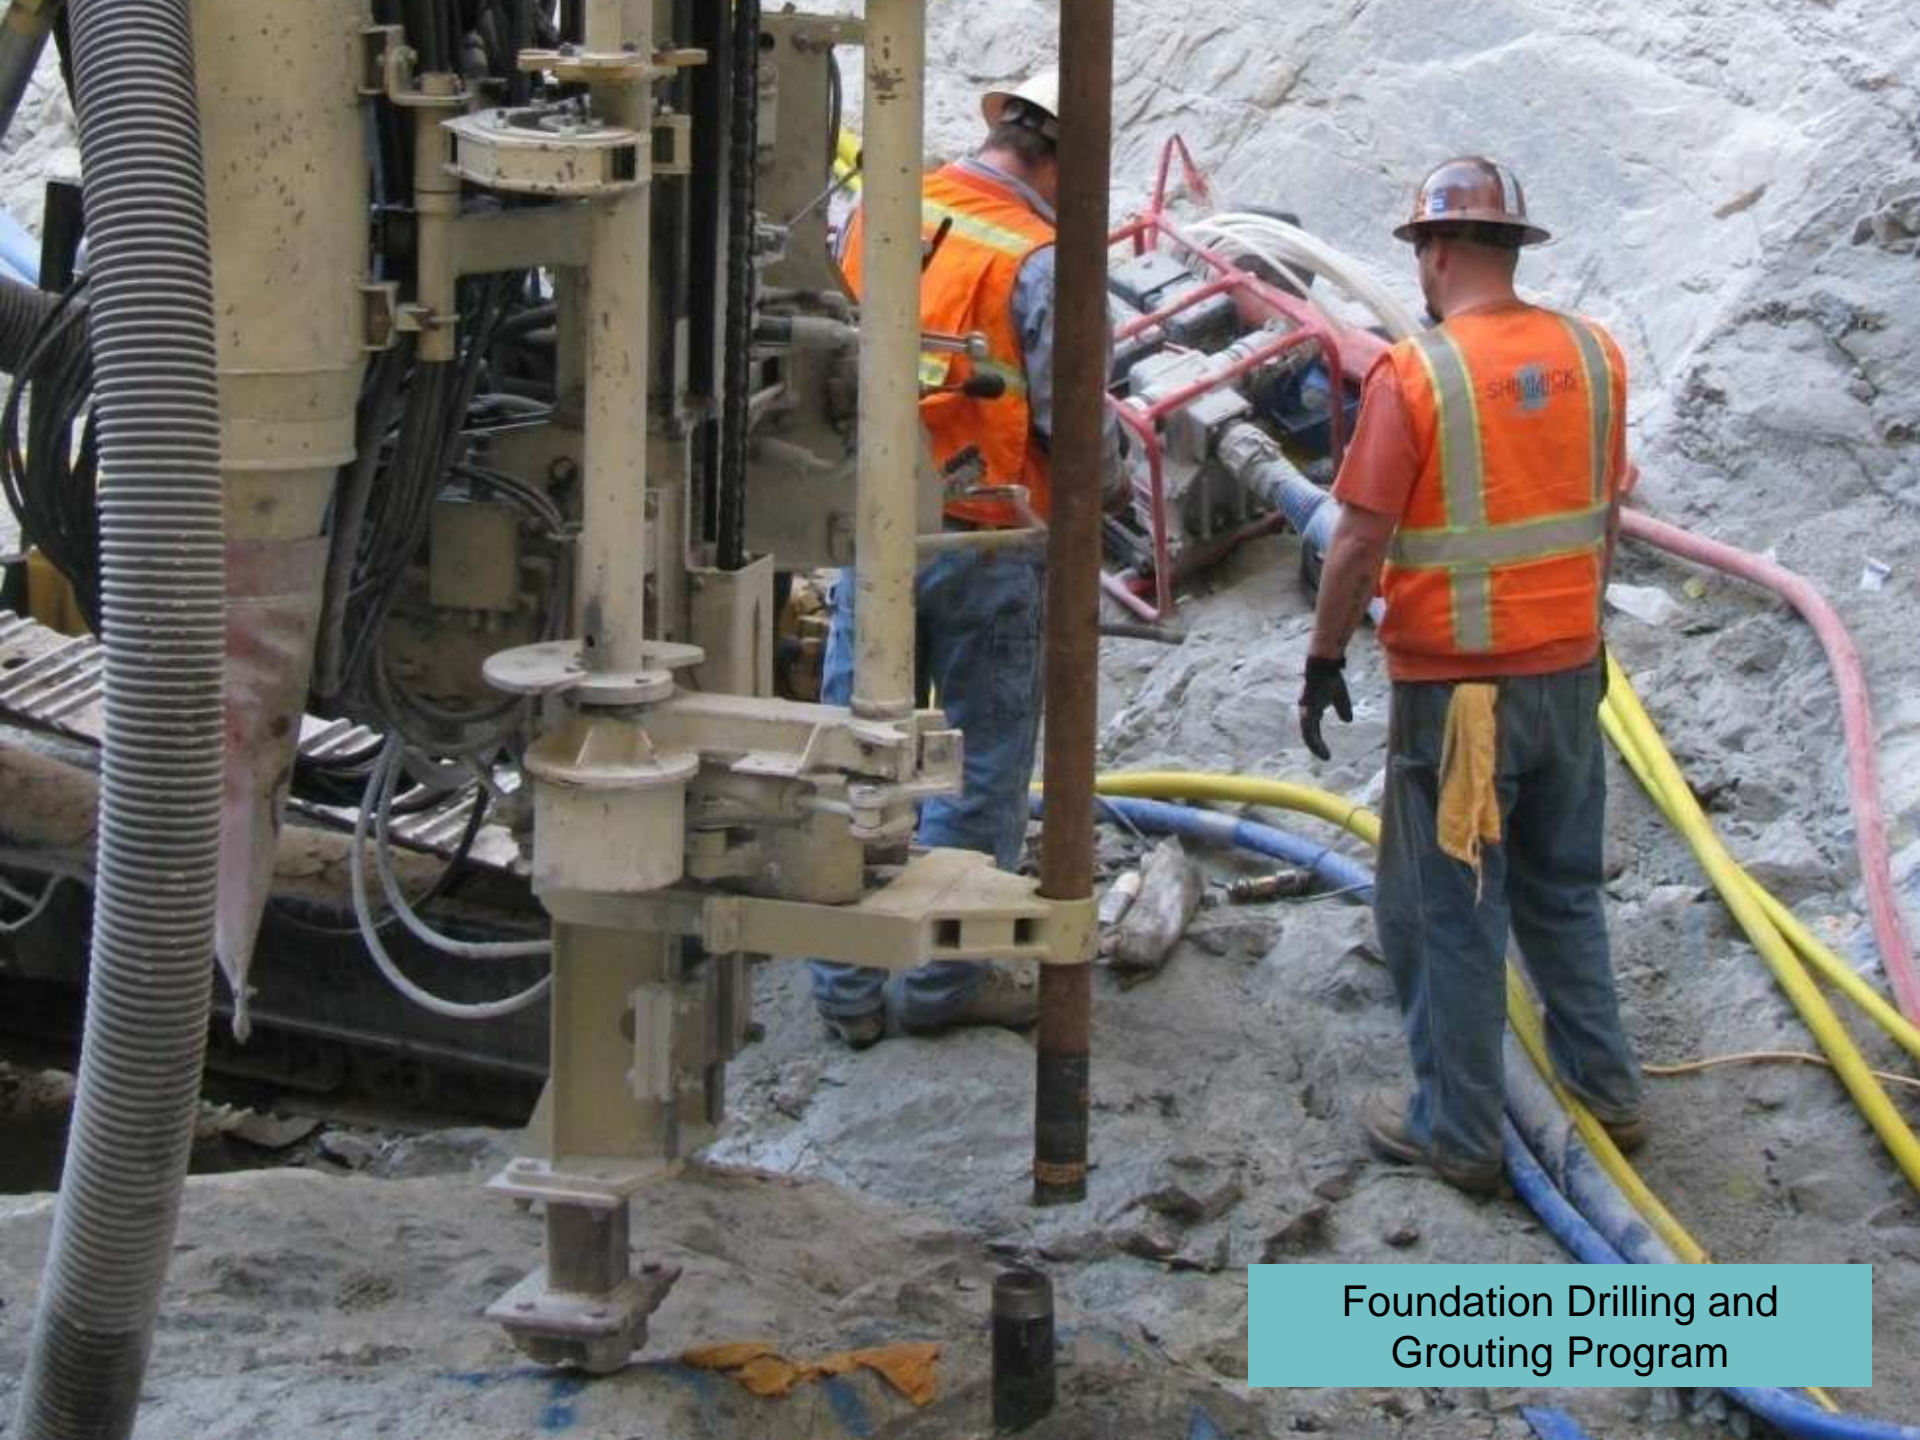
Foundation Drilling and  
Grouting Program

- 3:1 neat mix - 15 psi
- Closure Criteria 0.5 sack/ft of hole
- Artesian Pressure in the valley
- Changed to a stable mix (including Bentonite and Super P).

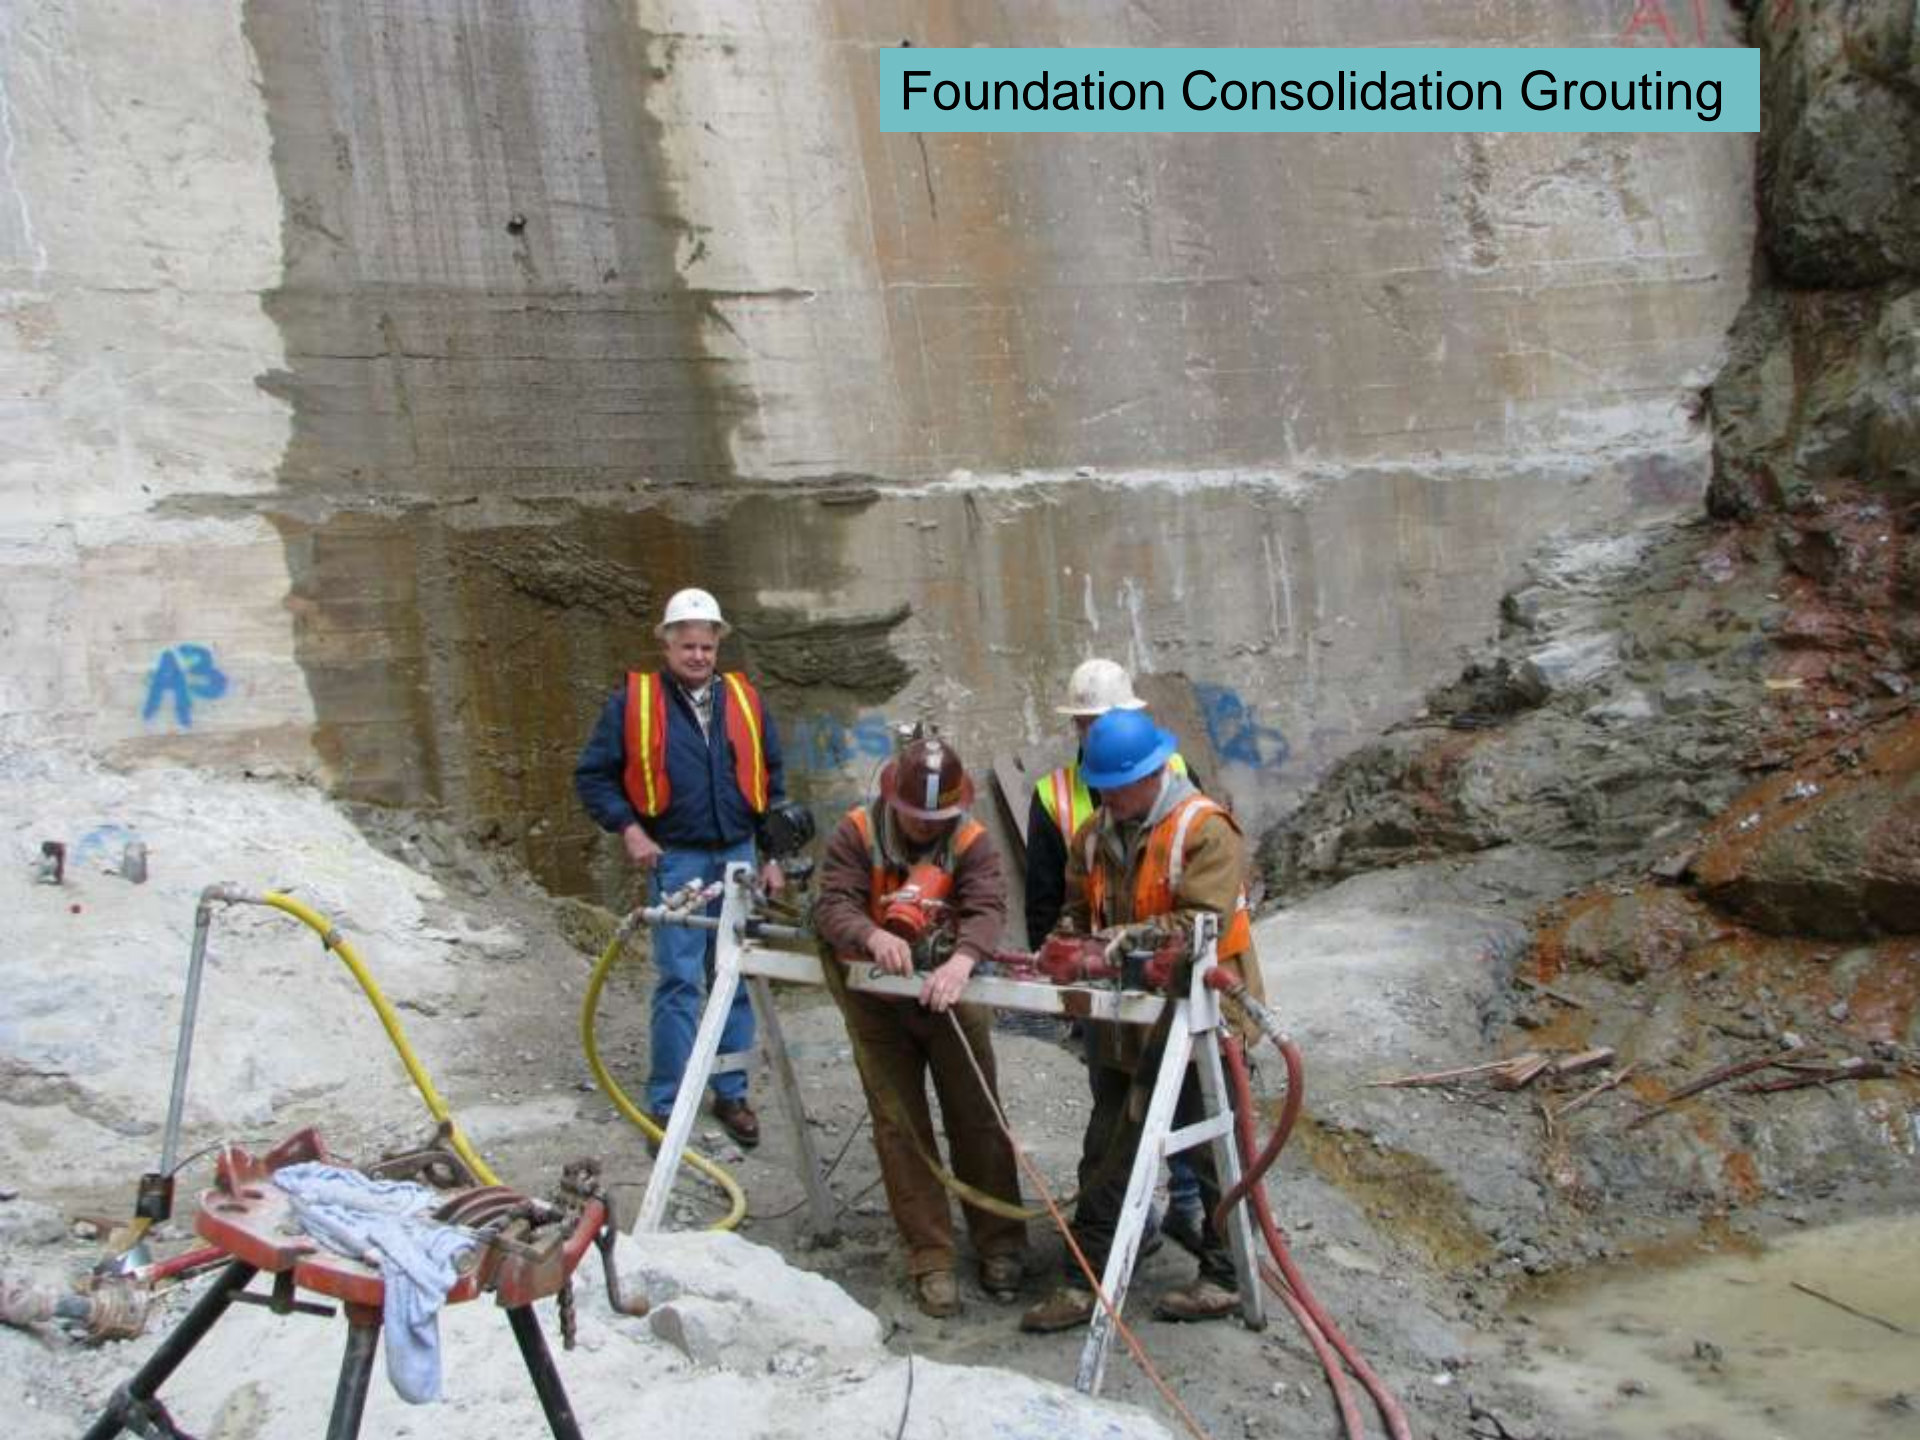
## Foundation Consolidation Grouting

Uplift Monitoring  
During Foundation  
Drilling and  
Consolidation  
Grouting Program

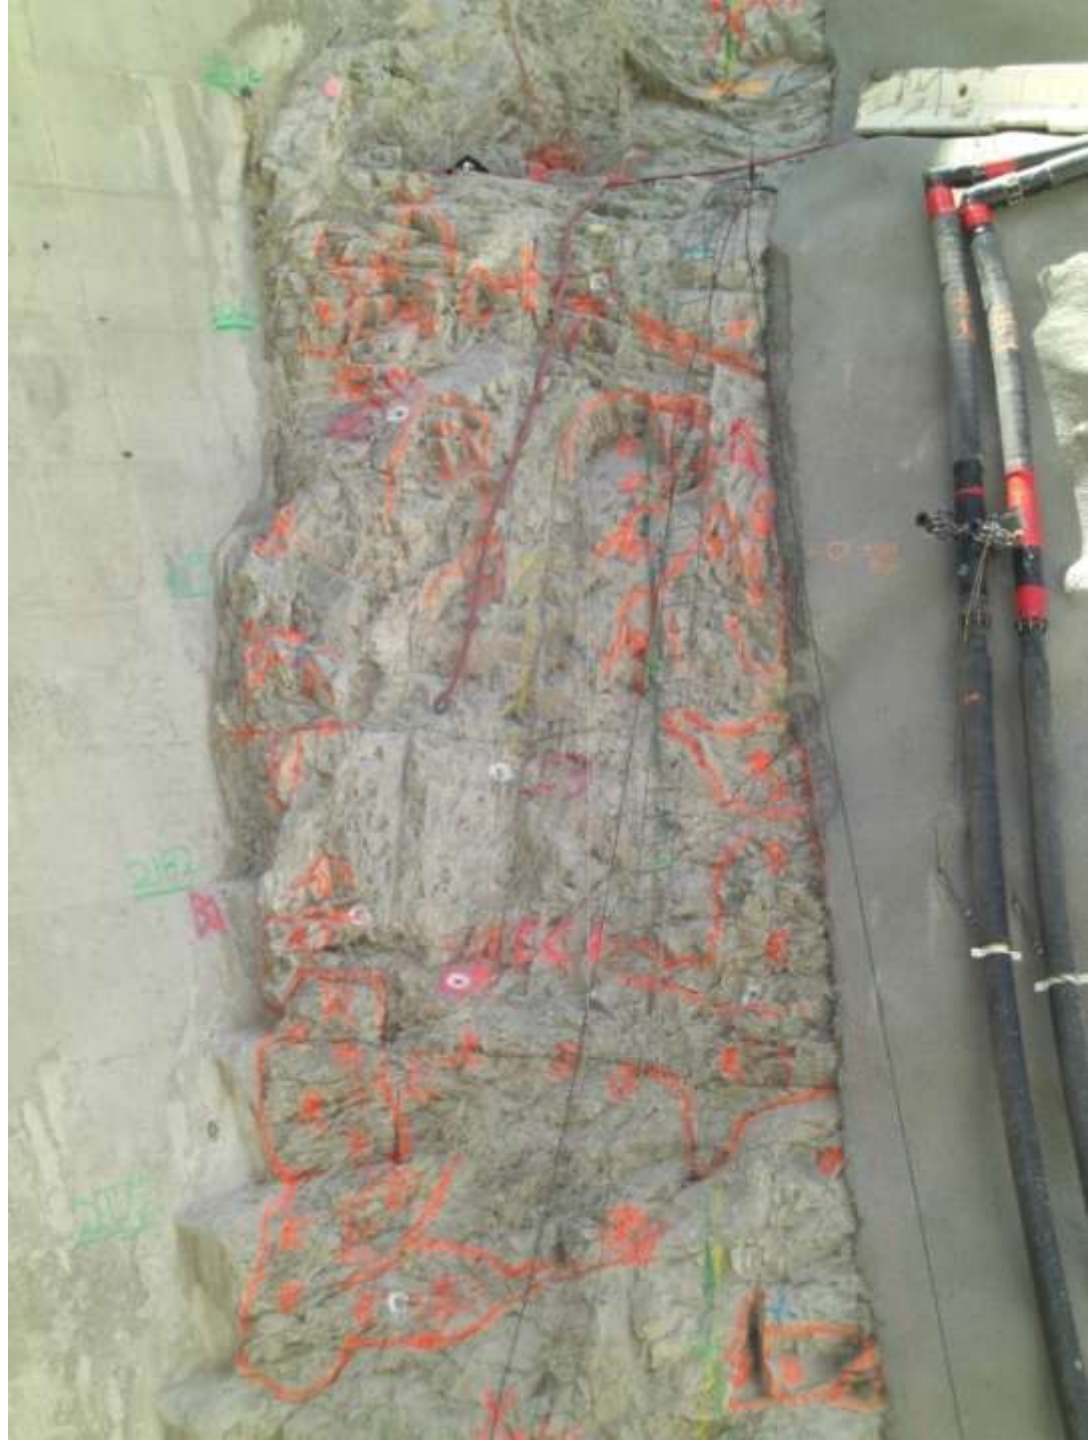
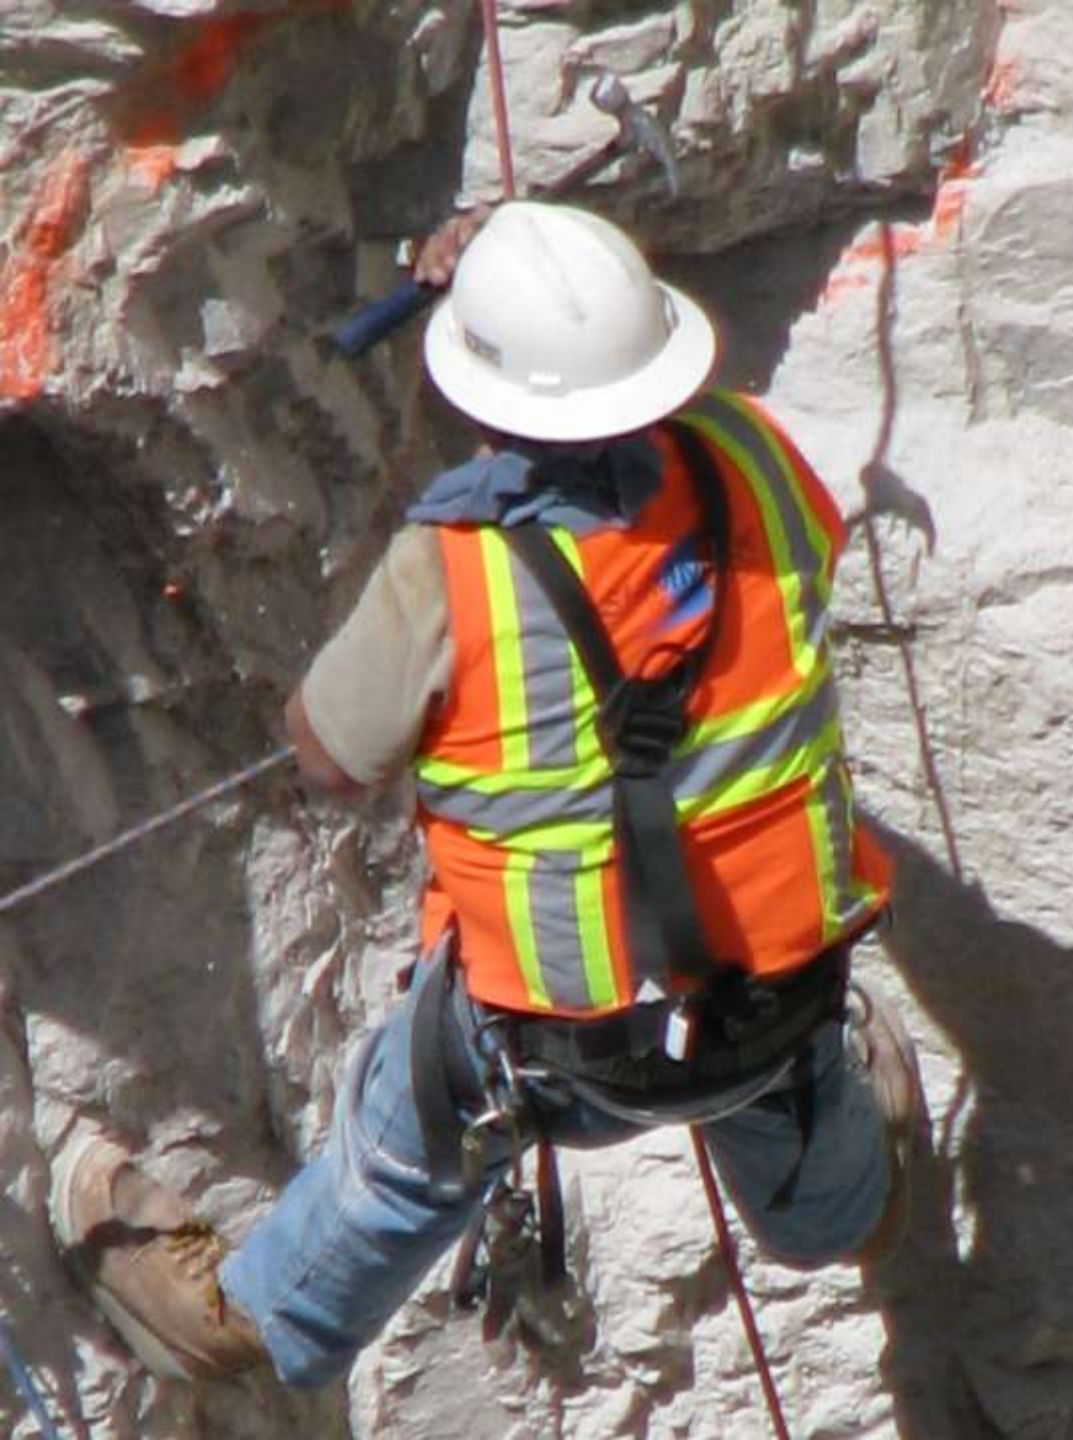
# Dental Excavations

R – Remove Loose Rock  
E – Excavate Shear Zones  
for Dental Concrete  
D - Dental Concrete Fills

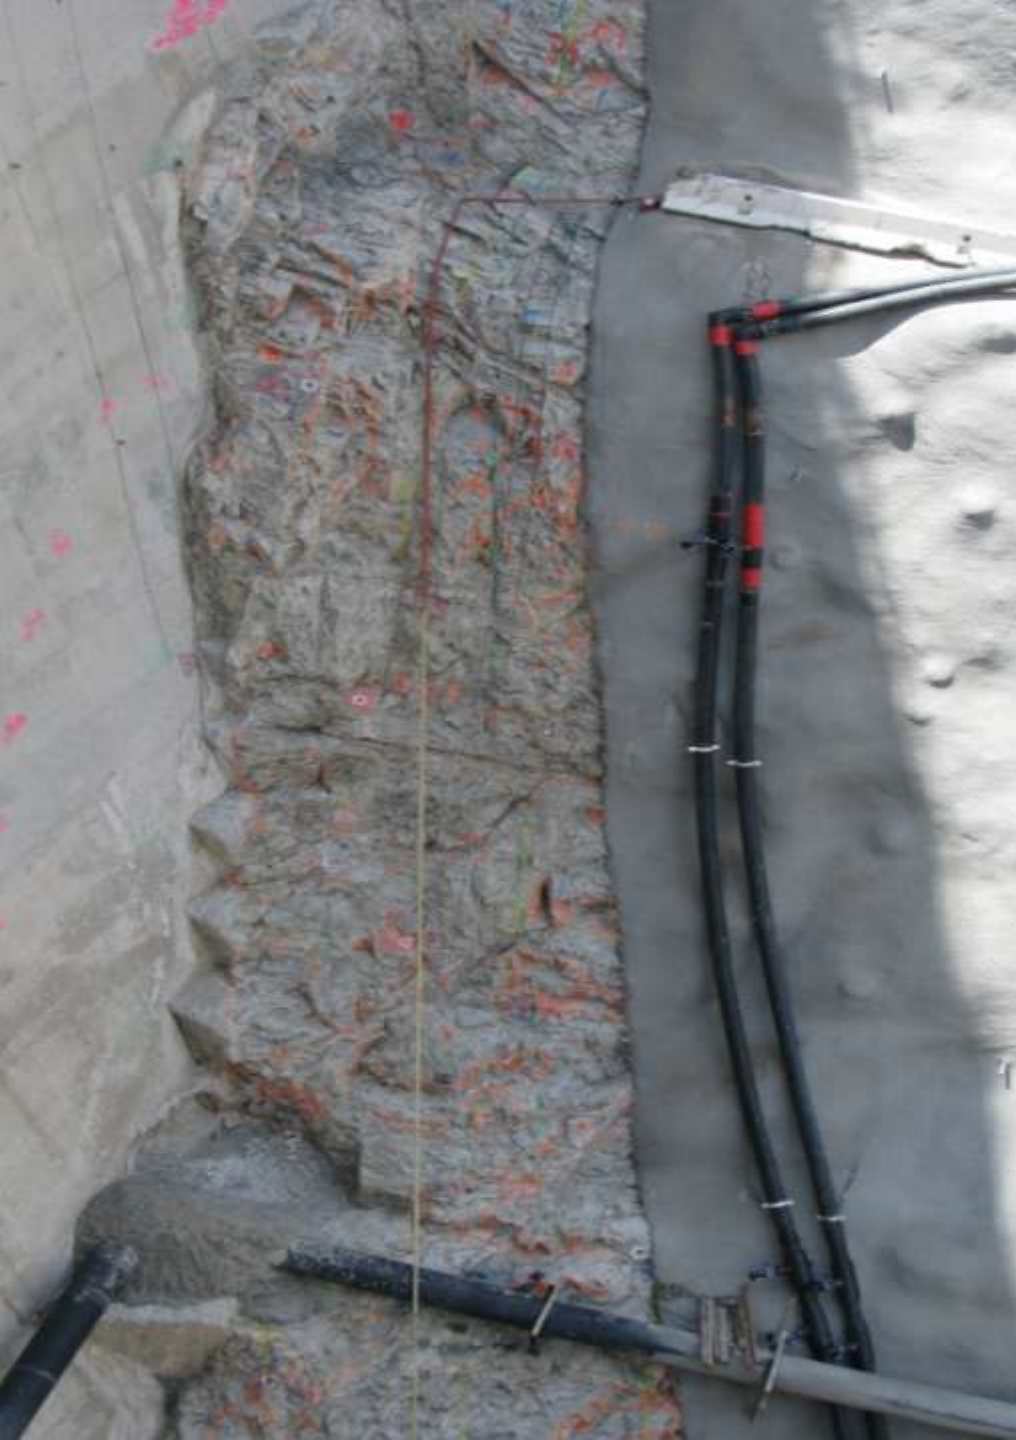
## Dental Excavations

- R – Remove Loose Rock
- E – Excavate Shear Zones for Dental Concrete
- D - Dental Concrete Fills

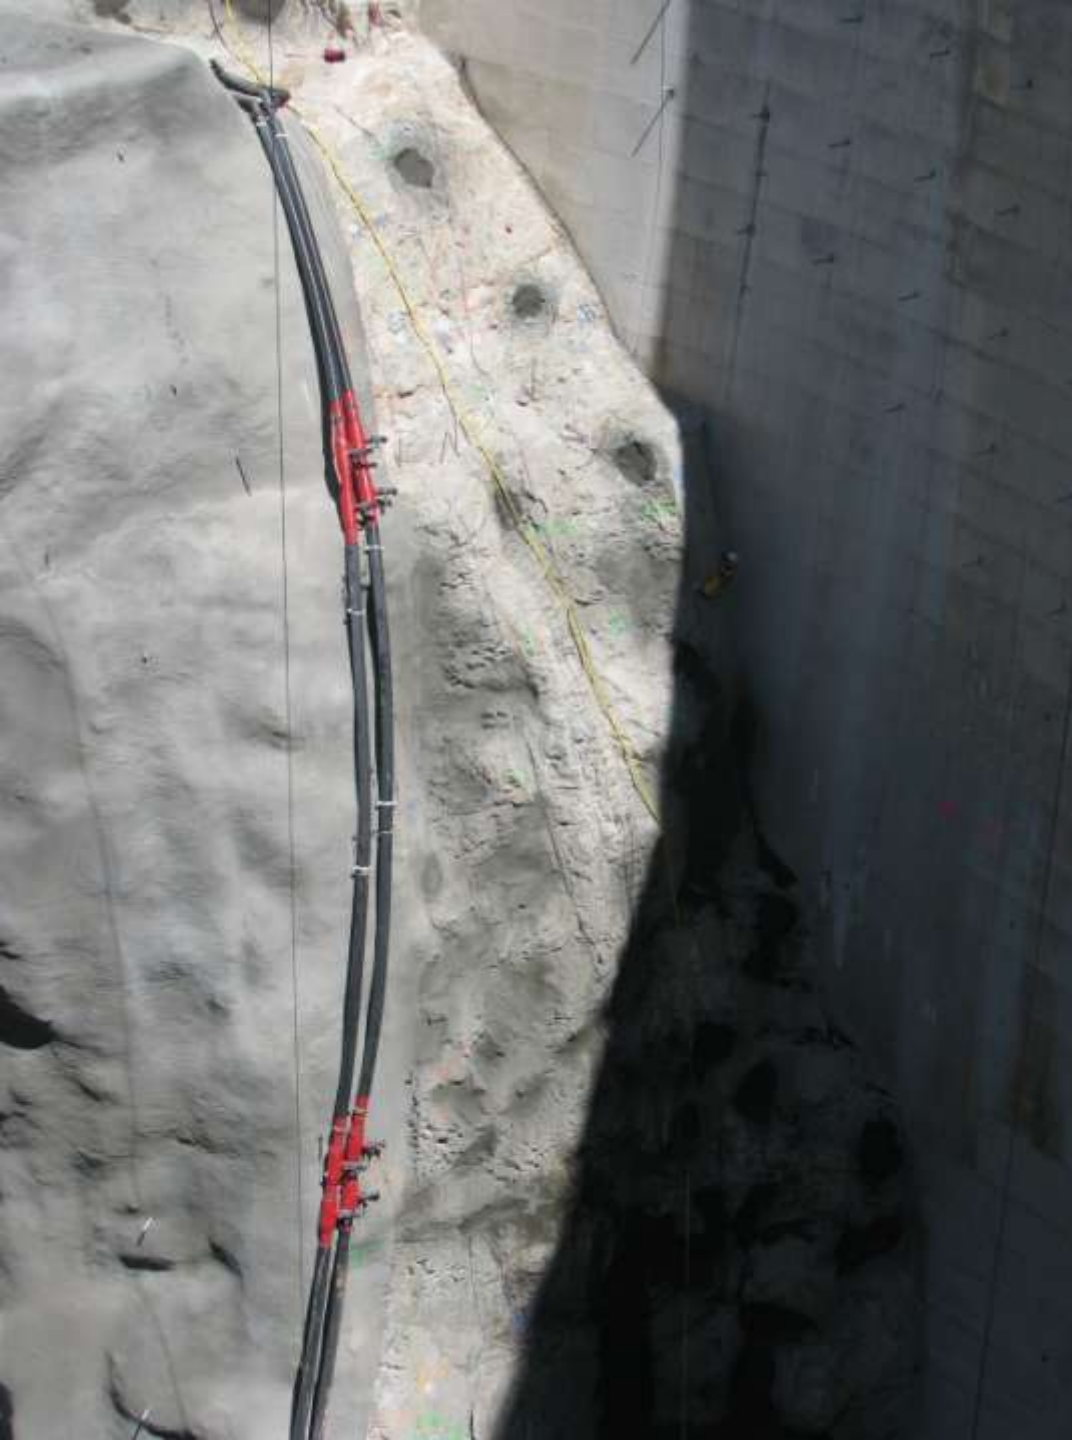
April 27, 2009

DSOD Approves  
Dam Foundation for  
Application of  
Dental Treatments  
(Dental Concrete  
and Slush Grout)

Pneumatically placed dental concrete placed on left and right abutments.

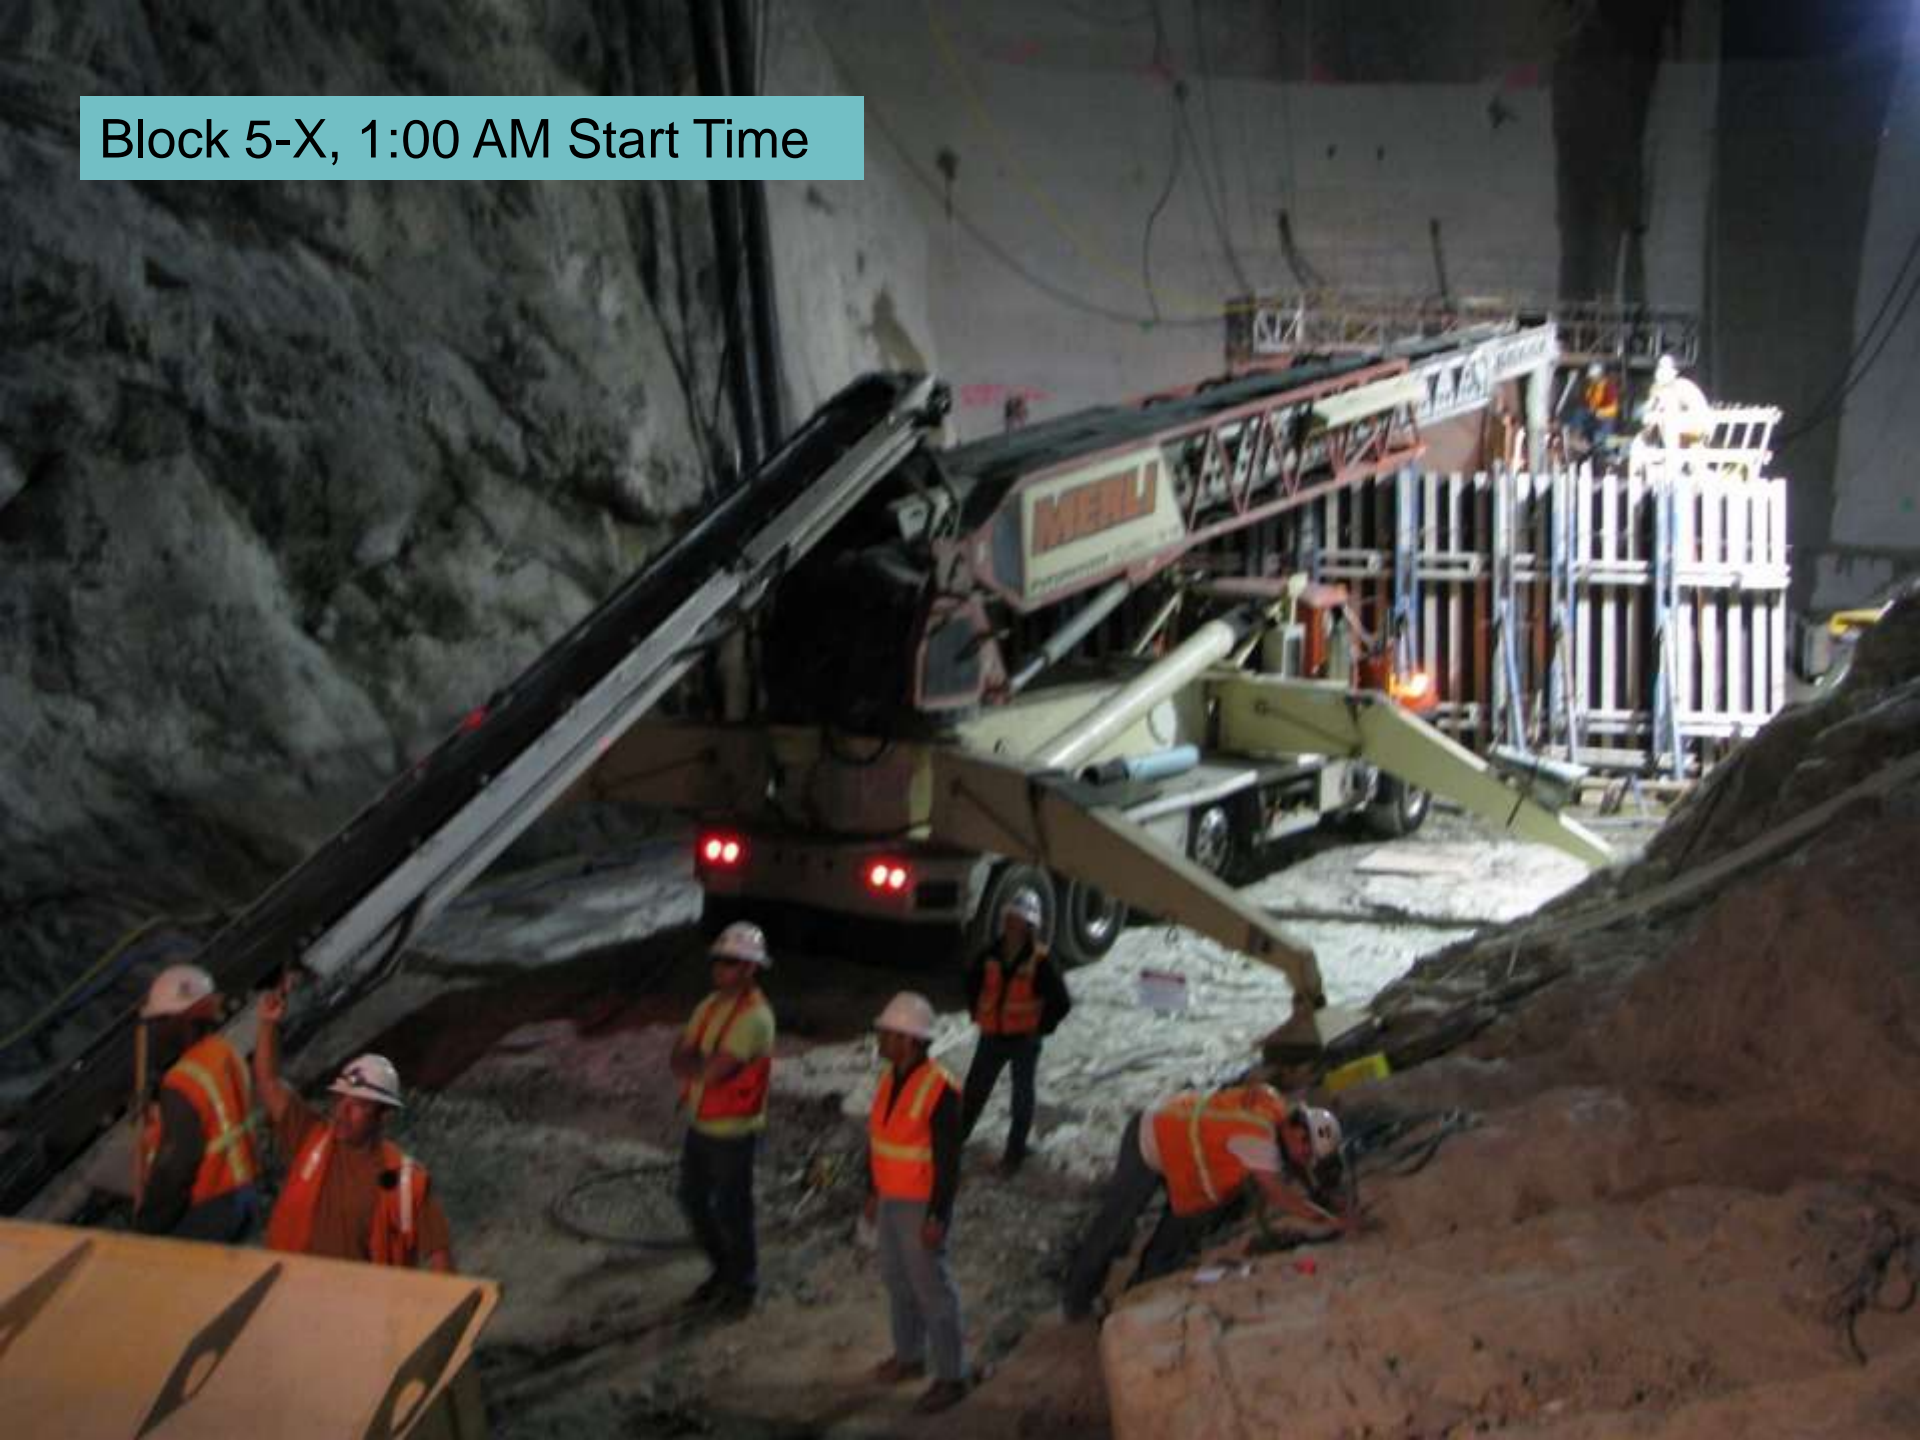
Block 5-X, 1:00 AM Start Time

Excavator with 6 – 4.5 inch  
Concrete Vibrators

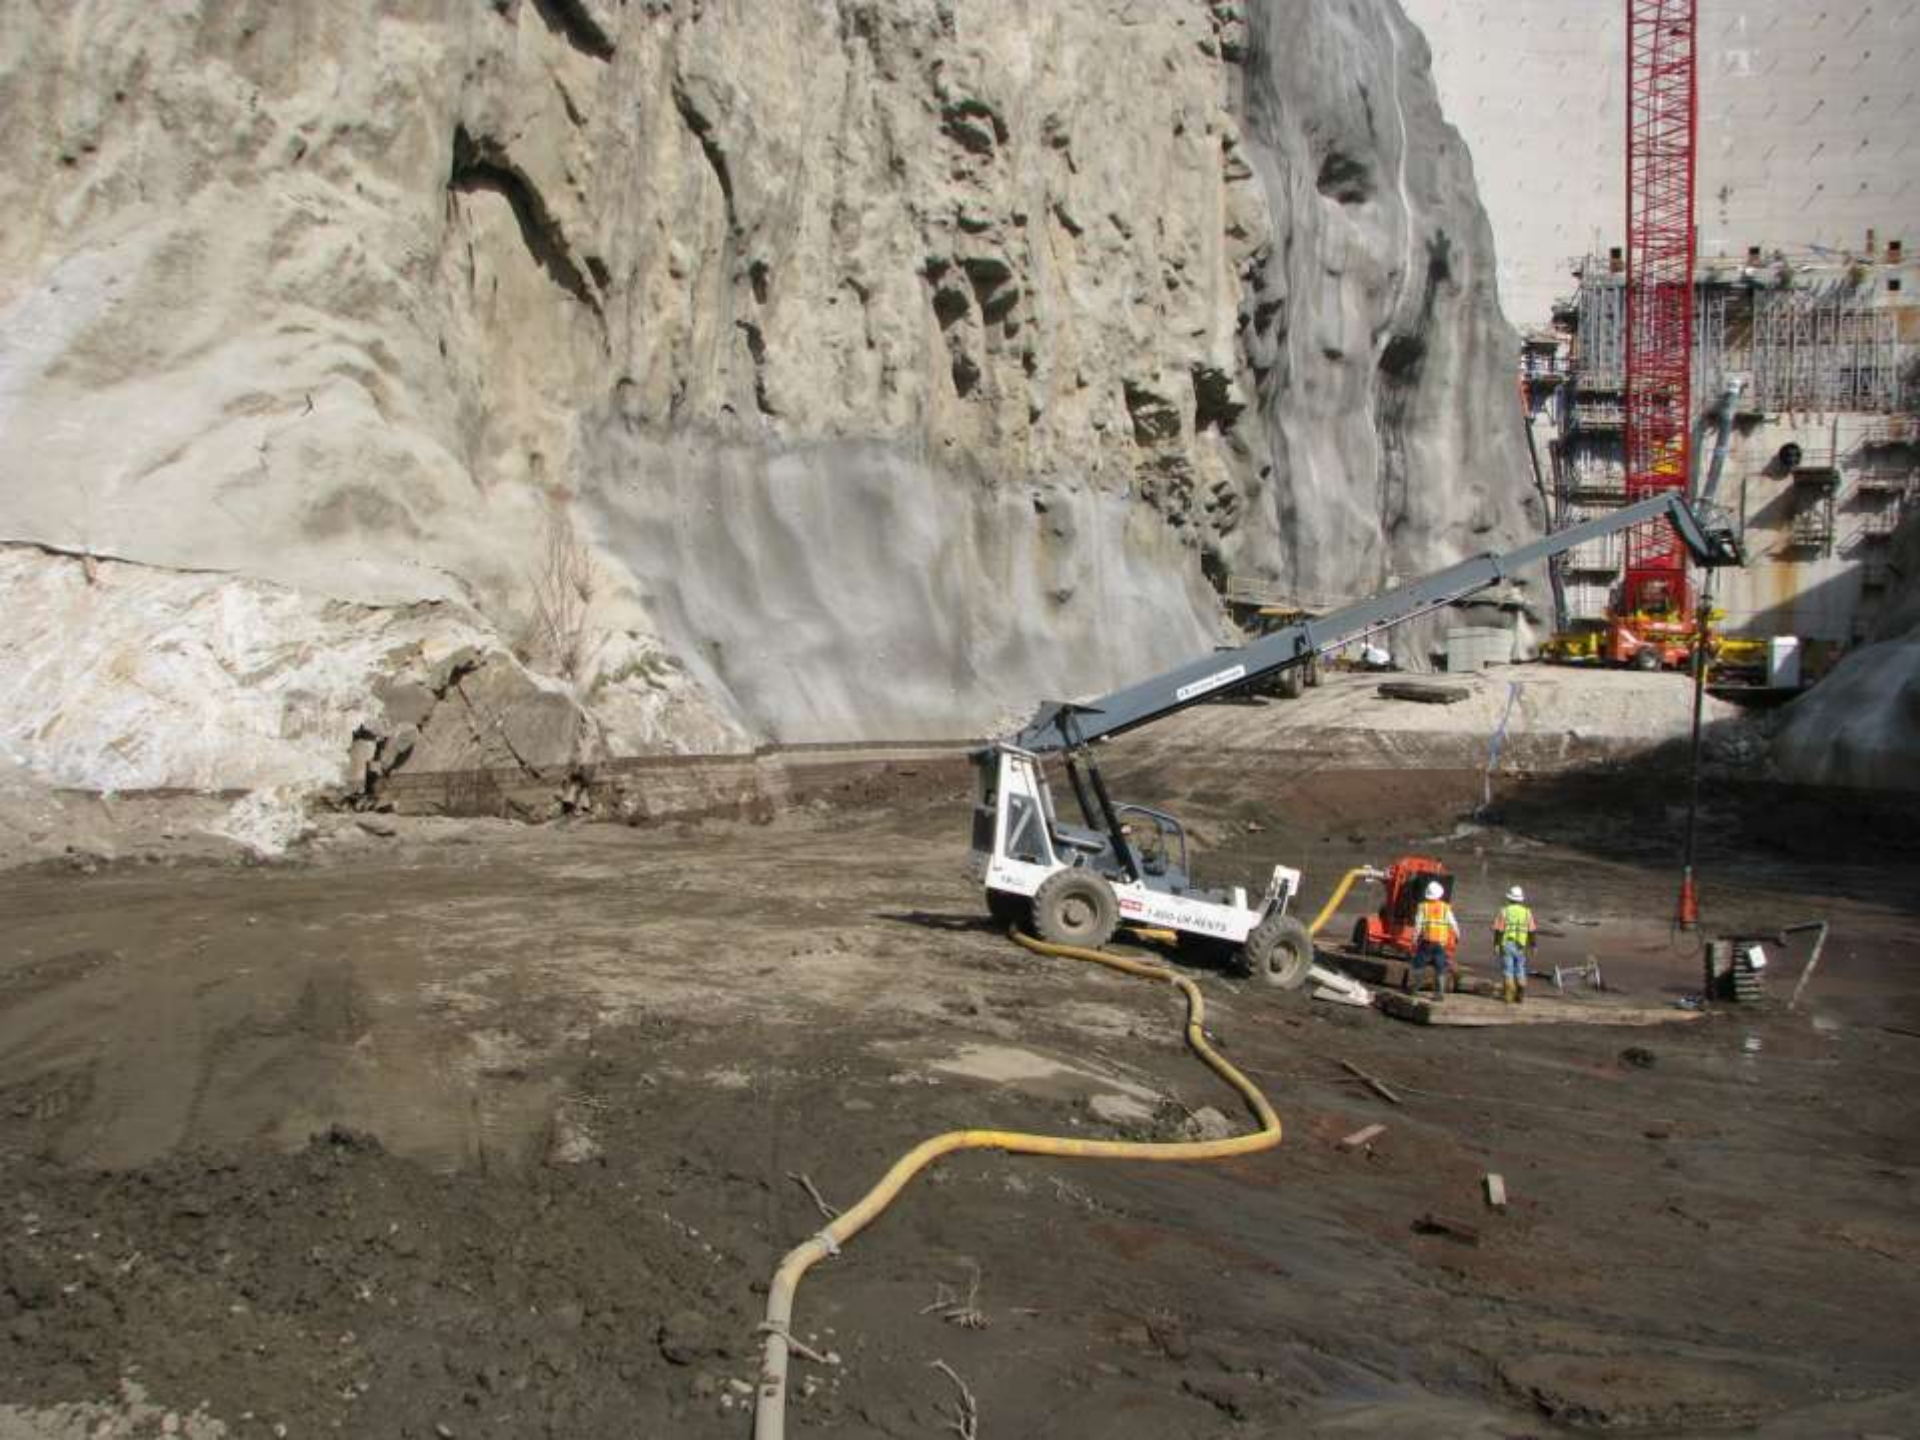
Dam Crest removal  
underway for new  
Ogee auxiliary  
spillway

Thickened Arch Concrete  
to Elev. 2261.28

40 degree Post-  
cooling water Piping

New Valve House  
underway
